Manhole Inspection Summary

Manhole # S41A2_023MH

Location Address: **3901 8th St.**

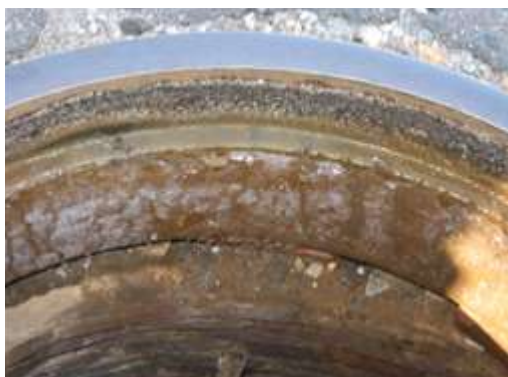
Defect 1

Condition: ☐ Sound ☒ **Cracked** ☐ Root Intrusion ☒ **Loose Brick** ☐ Deteriorated

Infiltration: ☐ None ☒ **Joint** ☒ **Cracks** ☐ Mortar ☐ Roots ☐ Wall

loose bricks under frame

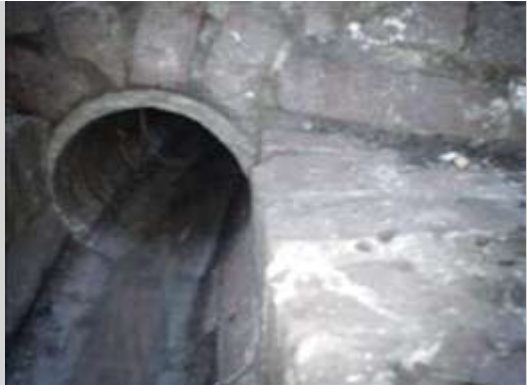
12 O'Clock Outflow

8 in. Circular Gravity Sewer
Pipe Out @ 12 O'Clock

Pipe Height: **9.6** (in.) Rod and Bar (Angled)
Pipe Material: **Clay** ☐ Pipe Lined
Invert Depth: **7.58** (ft.) Flow Characteristics: **Fast**
Deposits: ☒ None ☐ Mud ☐ Sludge ☐ Debris ☐ Grease
Silt Depth: (in.) Deposits Extent:
Infiltration: **None** Pipe Seal Cond: **Sound**

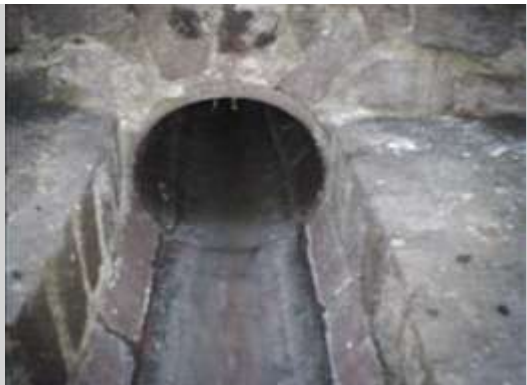
5 O'Clock Inflow

8 in. Circular Gravity Sewer
Pipe In @ 5 O'Clock

Pipe Height: **9.6** (in.) Rod and Bar (Angled)
Pipe Material: **Clay** ☐ Pipe Lined
Invert Depth: **7.39** (ft.) Flow Characteristics: **Fast**
Deposits: ☒ None ☐ Mud ☐ Sludge ☐ Debris ☐ Grease
Silt Depth: (in.) Deposits Extent:
Infiltration: **None** Pipe Seal Cond: **Sound**
